## 2016 – Notice to Shipping #19 MAISONNEUVE REGION MONTRÉAL / LAKE ONTARIO SECTION

## LOW WATER LEVELS ON LAKE ST. LOUIS

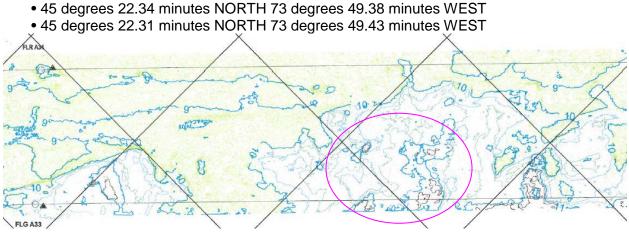
Two positions at 450 and 560 meters EAST of buoy A33 and at 80 meters NORTH of the SOUTH canal line.

In addition, we are asking mariners to avoid sailing over and SOUTH of the following positions:

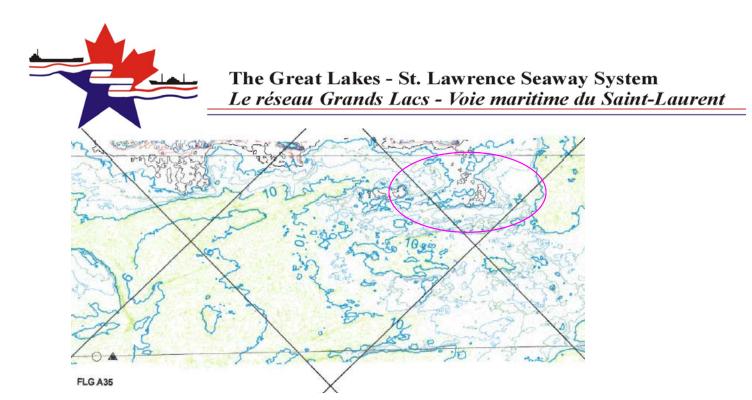
Also avoid sailing over and NORTH of the following positions: At 300 meters EAST of buoy A35 and 50 meters SOUTH of the NORTH canal line • 45 degrees 21.96 minutes NORTH 73 degrees 49.97 minutes WEST

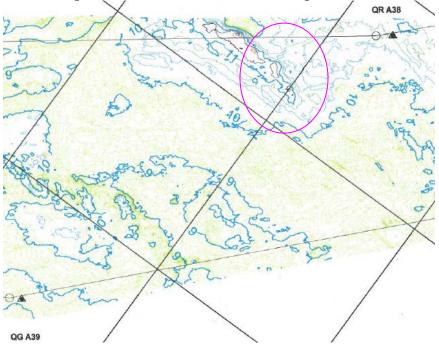
At 130 meters WEST of buoy A38 and 40 meters SOUTH of the NORTH canal line. • 45 degrees 21.56 minutes NORTH 73 degrees 50.55 minutes WEST
